Localized White Residue on Assembly

Localized Contamination Can Cause Big Problems

Localized residues can be overlooked through bulk testing methods

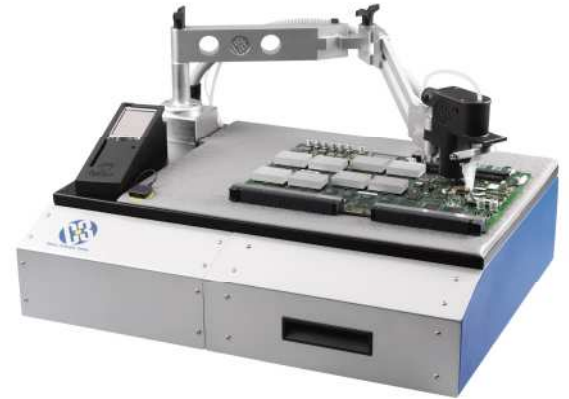
In today's electronics manufacturing environment, assemblers continue to overlook localized areas of contamination that are capable of causing product failures. By neglecting to examine sensitive localized areas, opportunities for electrochemical failures are exponentialized. The case we look at today involves a customer seeing visible white residues and dendritic growth in a connector area. Lucky for them, the residues were visible which caused them to investigate their source and potential damage. Many times, such residues are invisible and can go unnoticed until field problems occur.

troubleshoot this problem. For our analysis in this project, we utilized FTIR, SEM/EDX and Ion Chromatography analysis using localized extraction techniques with the C3 Cleanliness Tester. The FTIR analysis was able to show only flux residues. SEM/EDX showed a concentration of tin, lead, oxygen and copper. The high concentration of tin and lead caused us to deduce that electromigration was occurring in this area creating the white residue presence and visible dendritic growth. Because of these findings, we decided to analyze the area of white residue using ion chromatography so that we could better

The C3 Localized Cleanliness Tester allowed us the capability to extract a residue sample from a 0.1 in² area on both the connector area and its casing, as well as a reference area on the connector area and the casing. The C3 quickly showed 'Dirty' readings for the connector area with white residue presence and its casing area. Examining the reference areas on the connector and casing with the C3, we received 'Clean' readings for both. We took these four extracted samples and performed ion chromatography analysis. We found high levels of chloride, sulfate and weak organic acid (WOA) flux residues on the visible white residue sample from the connector and its casing. Conversely, we detected low and acceptable levels of ionic residue species on our two reference areas. This led us to believe that an external fluid contaminant had been introduced at some point and caused the visible white residues and dendritic growth. Looking at the board, the white residue appeared in a line like that of a drip, possibly caused by tap water which tends to be high in chloride and sulfate.

We recommended to this customer to monitor assembly processes more closely and determine the cause of the external fluid contaminant that was creating this reliability issue. This is one of a plethora of examples we have found in our lab's experience that is indicative of the importance of looking at boards in localized areas. If we were to have used industry test methods such as ROSE testing, the localized residues in this example could have been overlooked by extracting a sample from the entire board. This method would indicate that a residue problem did not exist, and that the white residues were potentially benign. The residues in this case were highly corrosive and were already causing problems that would only increase in the field. With methods available today, we are capable of looking at localized areas individually to catch problems such as this before residues become visible and dendrites appear on the board. This capability is a great stride advancing quality control in the electronics manufacturing environment.
